Finding a Foothold on an Uncertain Bank: An Assessment of Cerrito Creek into the Blake Garden

Nery Barrera Lopez, Moyan Chen, Timothy Cole, Tanner Howe, and Sara Mahmoud

LA 227 Restoration of Rivers and Streams
University of California, Berkeley
December 16th, 2019

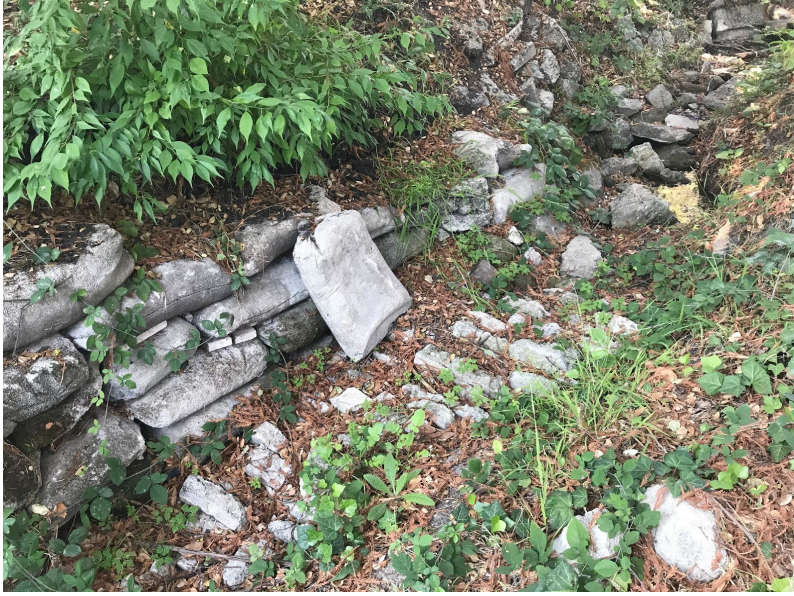
Figure 2. Failing sac-crete retaining wall along upper reach of Cerrito Creek within Blake Garden.

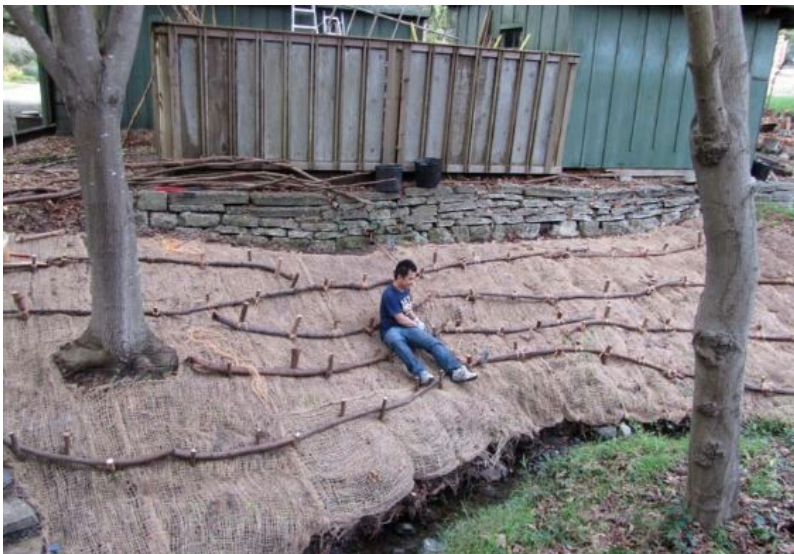
In 2009-2012, the period of multiple studies by the UC Berkeley LA 227 Restoration of Rivers and Streams class, the garden staff were undertaking a few restoration activities. Mostly this has consisted of removing the invasive species Algerian ivy and thornless elm-leaved blackberry. This seemingly never ending task continues today. The banks on either side of a bridge that leads to the main office were landscaped with geo-textile netting and planted with native and riparian plants (Figure 3).

Figure 3. A student stakes down a geotextile fabric on the northern bank of the upper reach of Cerrito Creek within Blake Garden. Upper reach of Cerrito Creek Phase 1 restoration, February 2012 (Blake Garden).

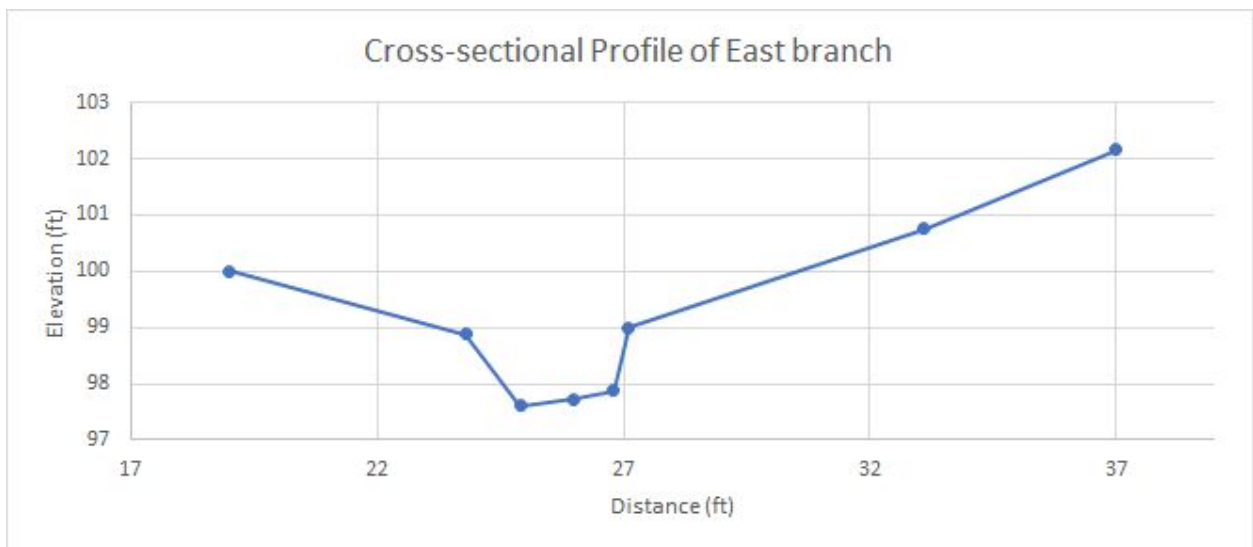
The cross-sectional profiles allowed us to see that both branches possess a wide channel. However, we could determine that vertical incision is occurring in the east branch of the upper reach, which, we have observed over the past year to carry less water (Figure 9). This might be an indication of regressive erosion in the east branch. In contrast, the bottom of the north branch has a wider bottom (Figure 10). This part of the channel was widened and its banks were reinforced with concrete (Sasaki et

Figure 9. Cross sectional profile of the east branch of the upper reach.

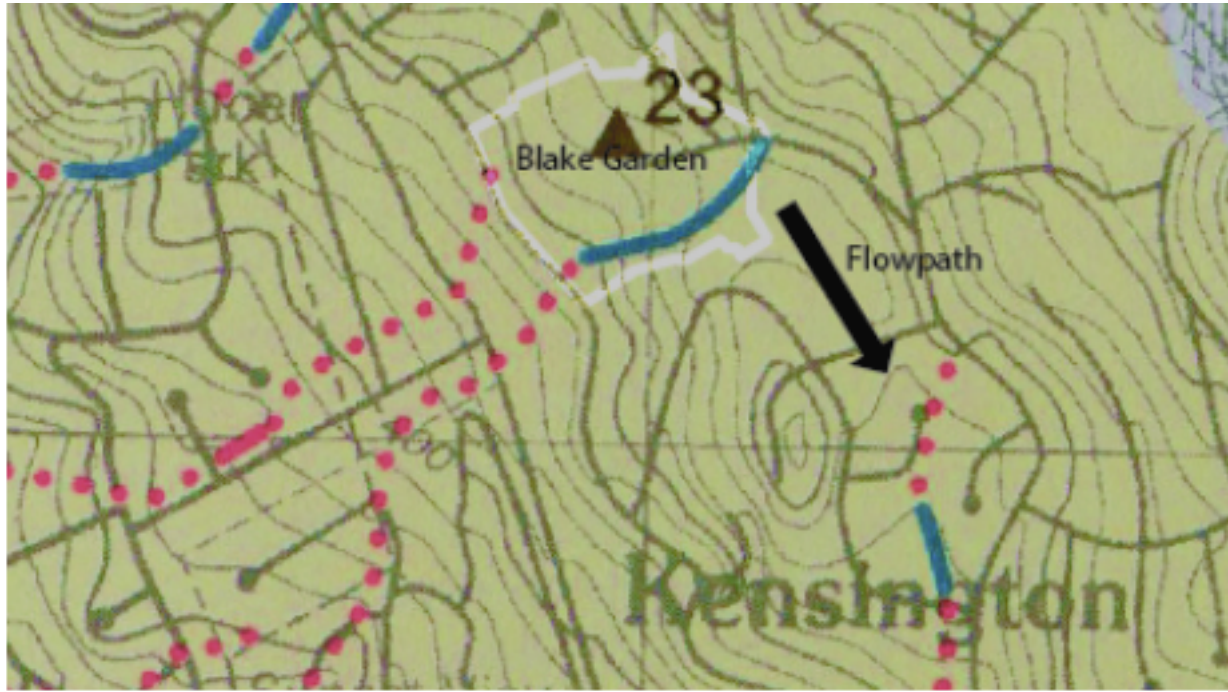
As we further examined the topographic map, we observed the possibility of a connection between the two branches of Cerrito Creek (Figure 16). The extent of the floodplain and topography suggest at least a historical or possible (under certain conditions) connection between the two branches. Upon observation of the land between the two branches, we discovered riparian vegetation and standing water suggesting there is a belt of continuous moisture through the region and possibly flow in the subsurface. We expect that with high enough flows surface water would flow over the divide between the two branches of Cerrito Creek, feeding both branches as depicted in the topographic map detail (Figure 16).

Figure 16. Potential flowpath between floodplain and lower branch of Cerrito Creek.
