# **Baxter Creek Gateway Park Restoration**

## **A Post-project appraisal**

University of California, Berkeley

LD ARCH 227 - Restoration of Rivers and Streams

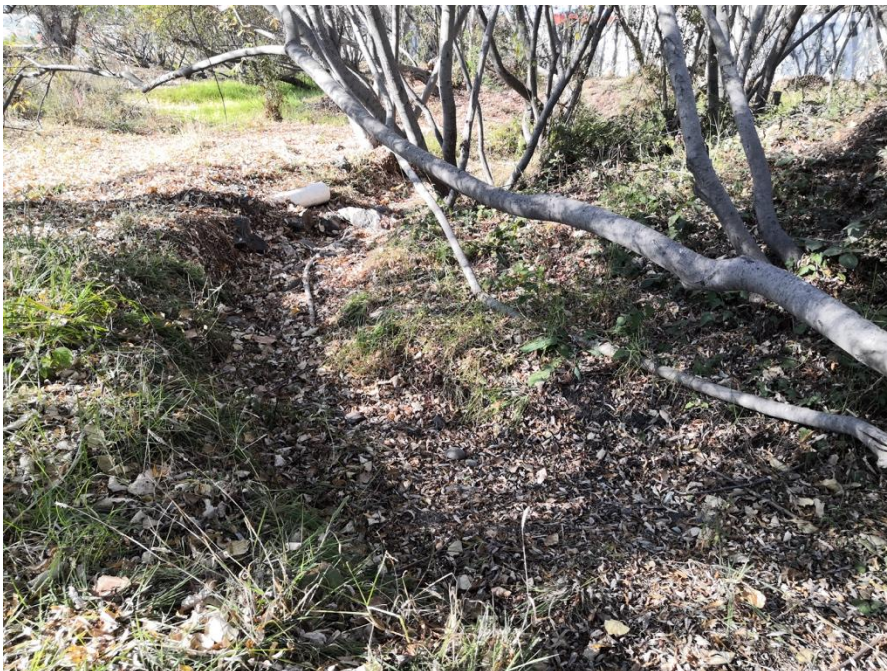
During the dry season, the midstream and downstream of the channel was dried out (figure 3.1.3), only the part of upstream have still water but most of which are covered by aquatic vegetation. Some parts of the creek bed are higher and intended to create the lateral connection (Figure 2.4.1). But as a result, these engineered weirs stop water flowing and create a small pond in the dry season (Figure 3.1.4).

Figure 3.1.3 channel dry out in dry season (base on the field visit on Nov.24<sup>th</sup>)

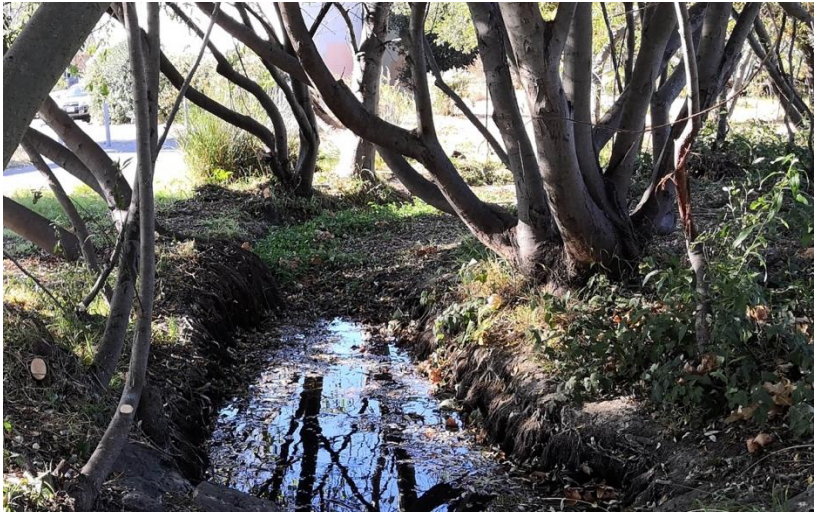
Figure 3.1.4 different level of creek bed create a small pond in dry season (base on the field visit on Nov.24<sup>th</sup>)

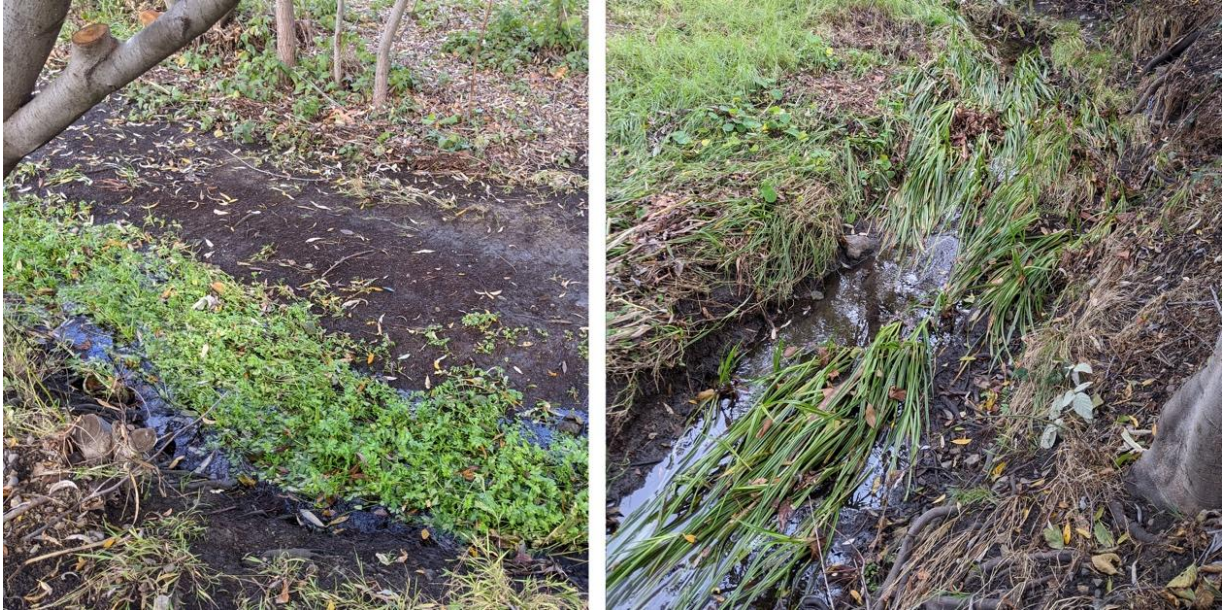
During the wet season, the whole channel has running water, but the water depth is quite shallow, and it is easy to see the bed material through water. The upstream of the channel is covered by two different aquatic plants, the plants with long leave are dominating the area close to the outlet culvert, and the small leave plants are dominating the rest part of the upstream channel (figure 3.1.7)

Figure 3.1.7 Creek bed covered by aquatic plants

What we found out during our 2nd survey was that where there is a big rock, there are lower chances to get undesired aquatic vegetations. Thus, we assumed that keeping supplies of cobbles and boulders into the creek bed could avoid the channel being blocked.

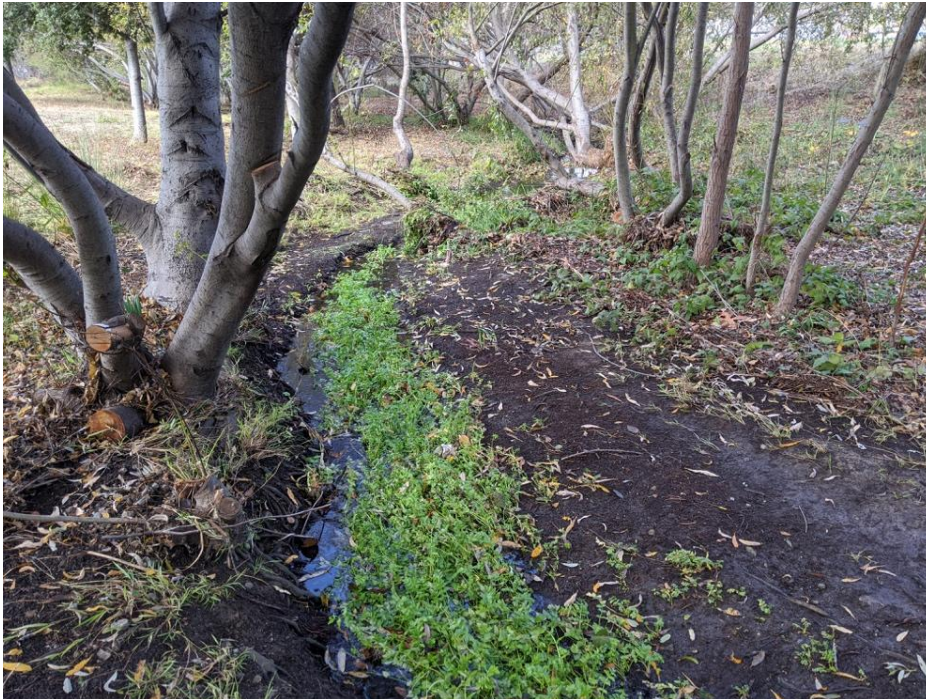
Figure 3.1.8 Growing aquatic plants narrow the channel width

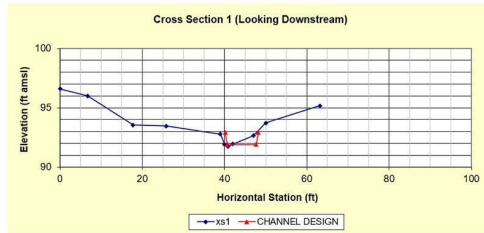
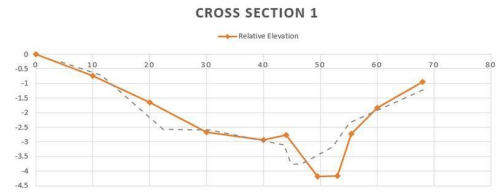
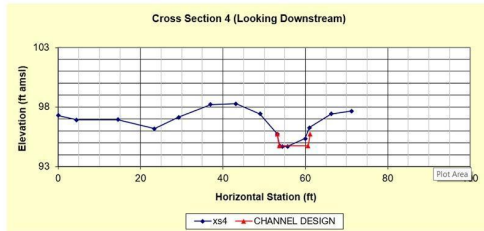
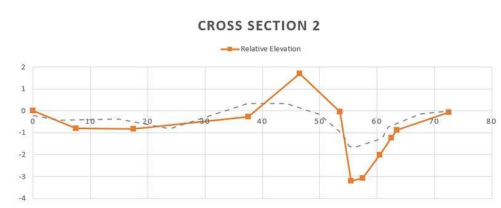
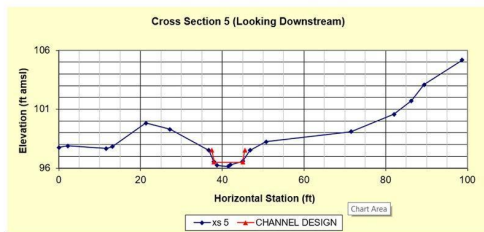
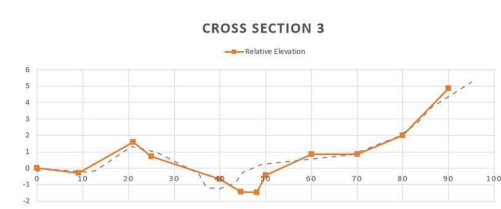
Figure 3.1.8 Cross-section maps

Overall, the creek bank is shifting, the down-stream creek bank suffers more erosion than upper-stream, **as we can see** more changes in Section 1&2 (Figure 3.2.1) when compared to Section 3&4 (all sections looking downstream). The east bank of Cross Section 1 moved downward and eastward with 3 feet difference and the west bank became slightly higher and flatter, moving 0.5 feet Northward. The creek bed of Cross Section 2 moved downward about 1.5 feet and the west bank increased 2 feet higher than before and the east bank moved a little lower. The movement of the creek bank in section 3 is different than our expectation because the bank there seemed not to obey the rule of how creeks deposit and scour in meandering shapes. The creek bed and bank moved eastward in the last 13 years. Cross Section 4 is the relatively least changing one, as the east bank moved eastward a little while the south bank kept almost the same.

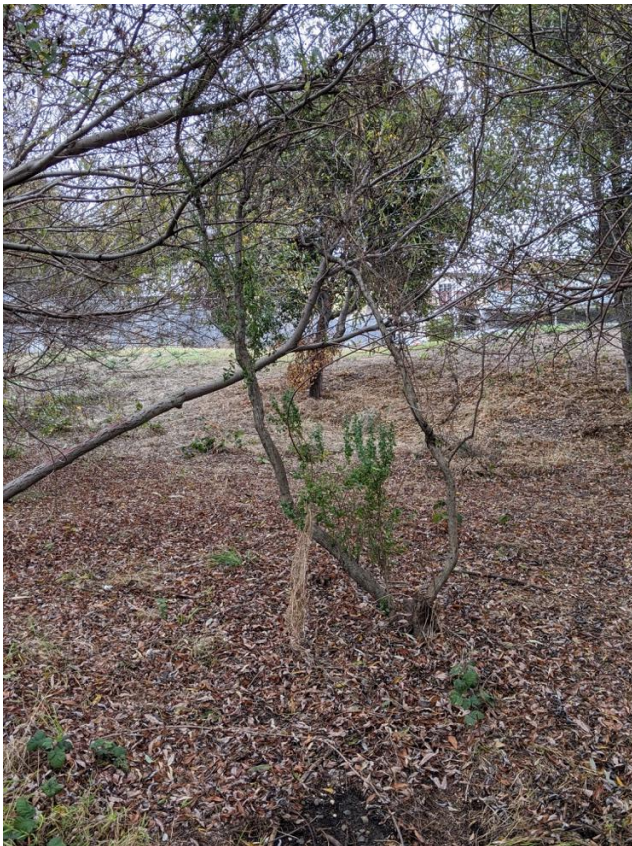
The trees shown in the planting plan (Figure 3.3.1) have some are in good condition, and some are not. The Oak grows in good shape, but the Alder and big leaf maple are hard to recognize, most of them are dead and not functional anymore ( Figure 3.3.2). Moreover, the "container stock" bushes were hard to discover in the selected area, where there was just bare soil and some covered with grass. According to species studies, we found several invasive species in our chosen field, such as Mustard Species, which grows along the road, and Broom Species, which grow flourishingly in our site. Another significant issue is the expansion of willows, which take over space and shading large amounts of area, thus competing for the sun and nutrition with other riparian plants and blocked the creek view.

Figure 3.3.2 A most dead Alder

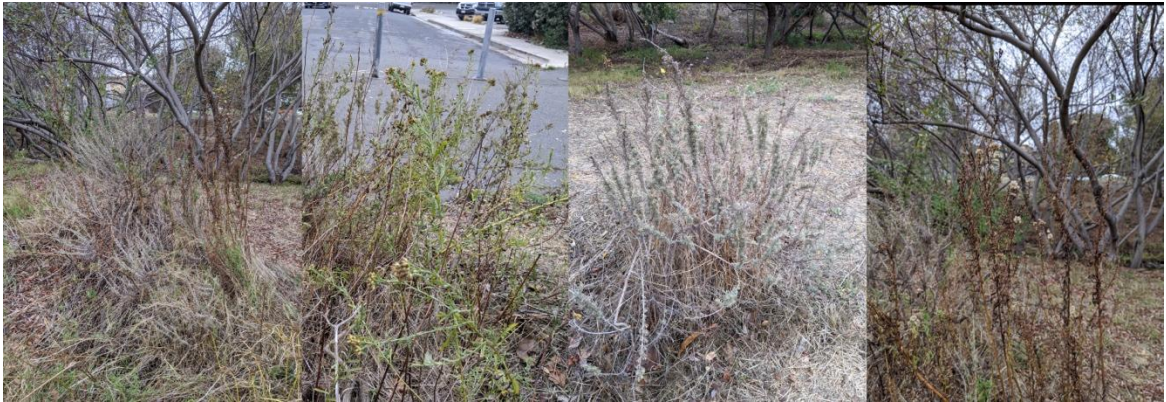
Figure 3.3.3 The invasive plants

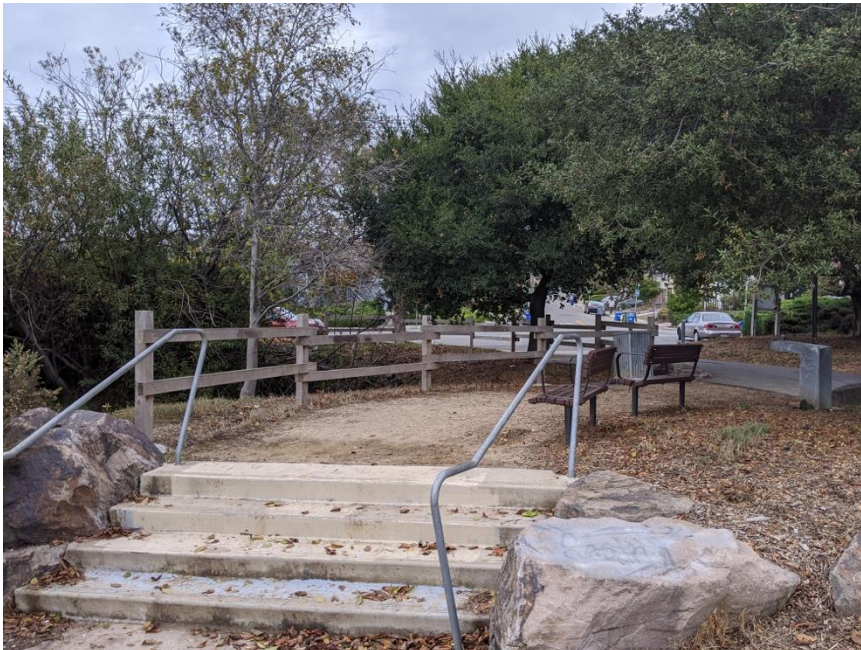
We also found that there are not so many people staying in the park. Even though there are some people attracted by the creek or read the information boards, there are few people choosing to sit in the park and spending longer time there. The park has a lack of sitting elements, there are only two chairs placed in the entrance of the park (figure 3.5.6), but when I

sit on the chair, I can only see the crown of the trees but not the channel. On the other end of the park, some stones are providing sitting possibilities, but the height of rocks is not comfortable to sit on it (Figure 3.5.7)

Figure 3.5.6 sitting chair of the park
