What's Past is Present: A Re-Evaluation of Cerrito Creek

University of California, Berkeley

LD ARCH 227 - Restoration of Rivers and Streams

December 17, 2018

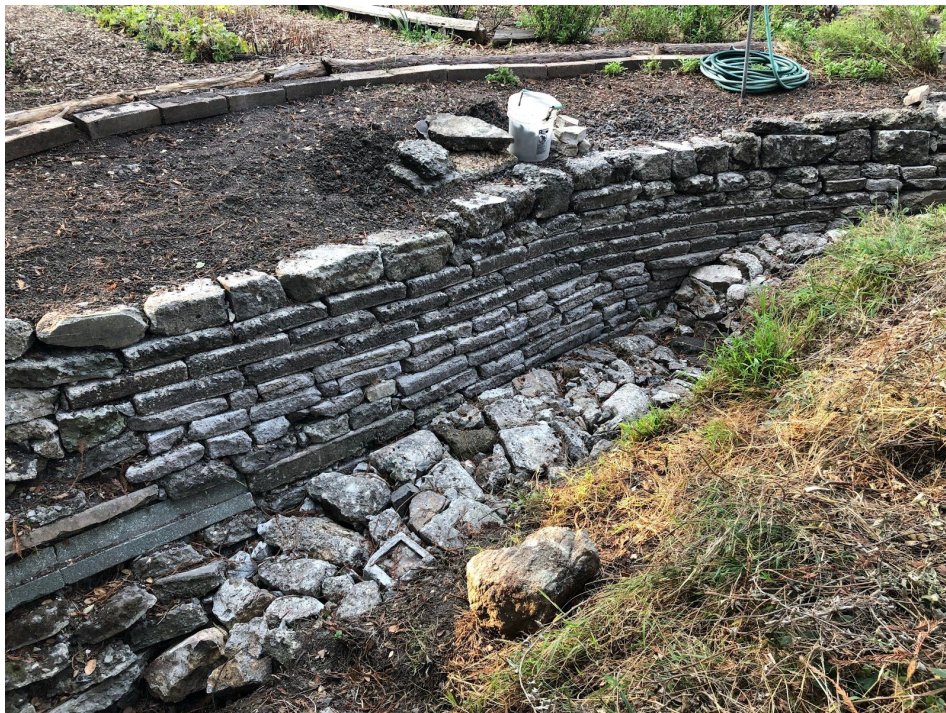
Both Ray and Cole noted that the portion of the creek that they were currently most concerned about was the area near the greenhouse and the recreation area. This area has been experiencing high levels of erosion and has been slowly encroaching upon these key areas. Attempts to stabilize the banks of these areas have been made in the form of concrete reinforcement (Figure 3). Mike Frappier has been using concrete bricks and concrete cylinders to create an artificial bank that would be more resistant to erosion.

Figure 3: Concrete reinforcement of a portion of the creek.

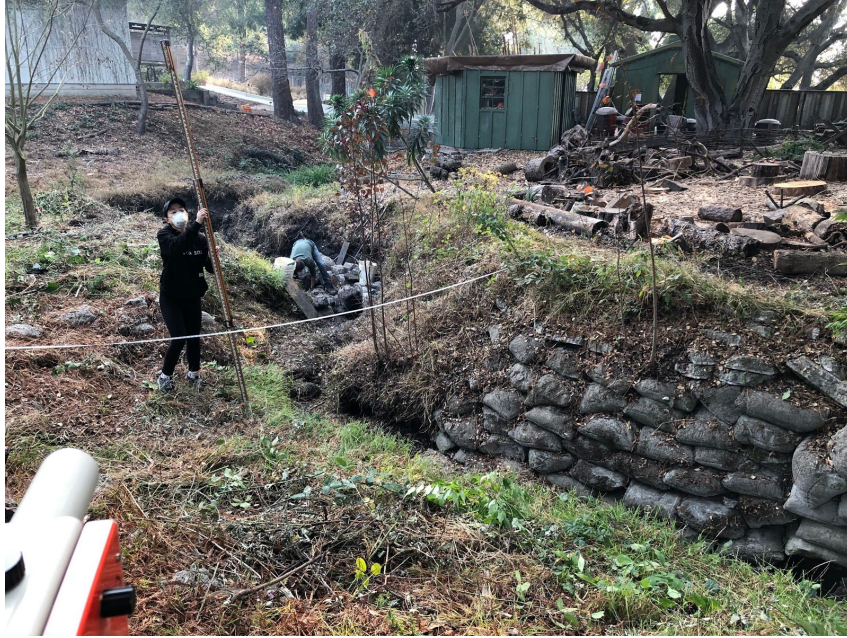
Figure 4: Sac-crete reinforcement of the creek near the recreation area

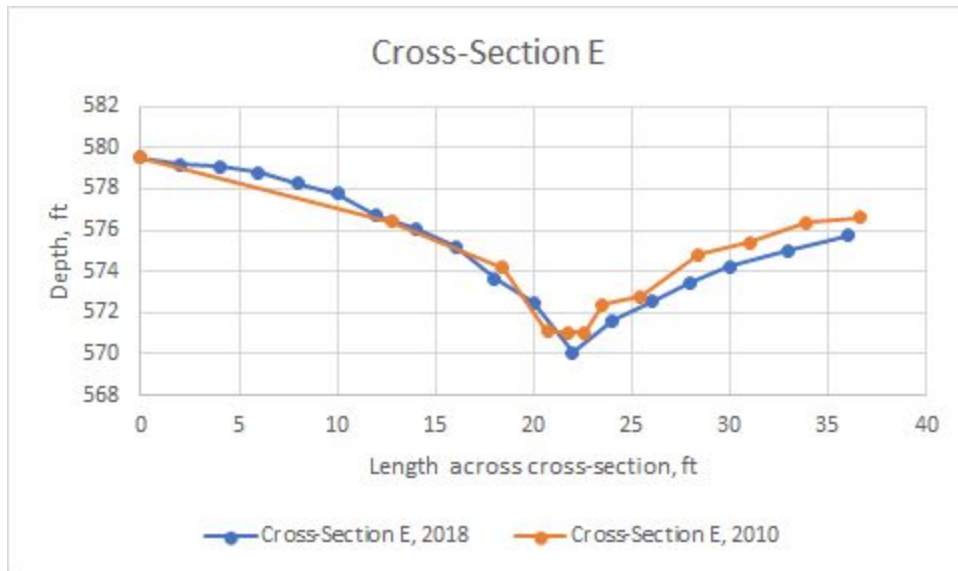
Figure 5: Survey results of cross-section E from 2010 and 2018 show a similar profile showing no large incision or erosion over the years.

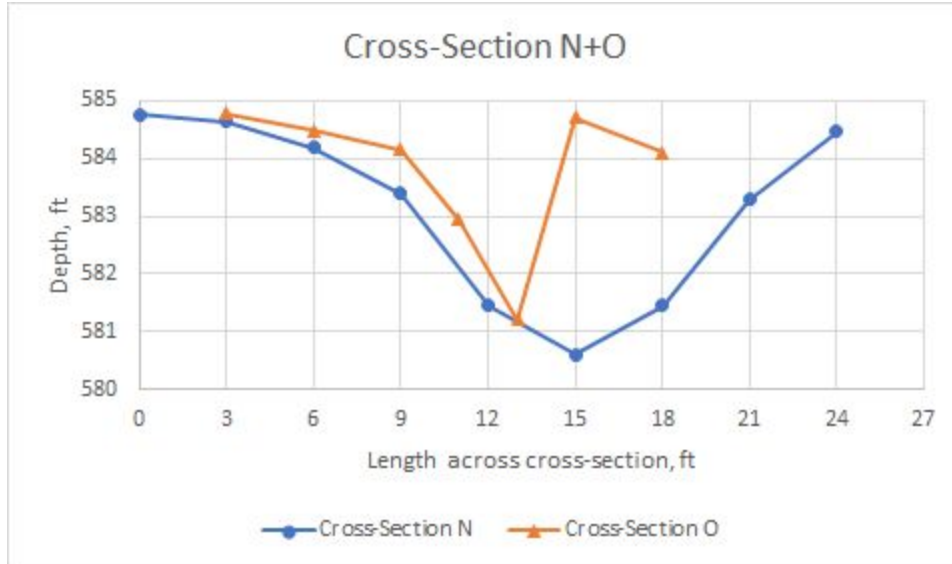
Figure 6: Survey results of cross-sections N and O that show the narrowing of the creek as a result of the concrete stabilization.

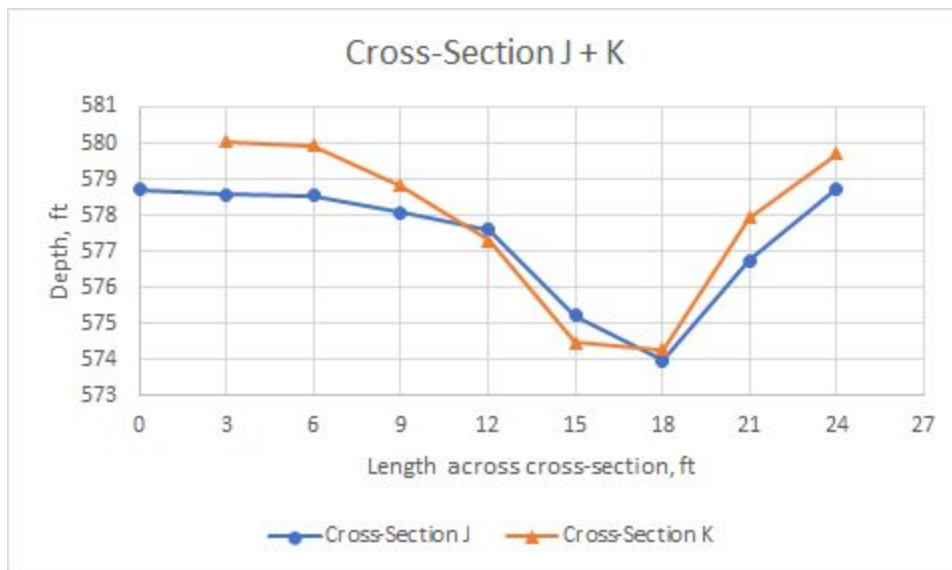
Figure 7: Survey results of cross-sections J and K that show the erosion taking place right after the concrete stabilized portion of the creek.

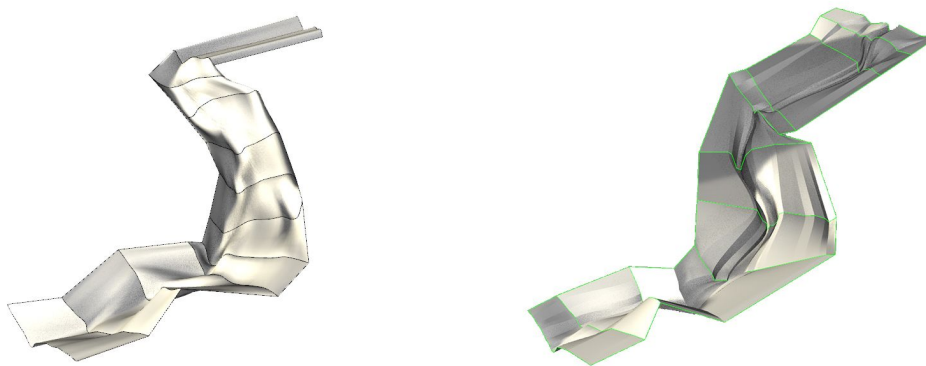
Figure 12: Left: Interpolation of 2018 cross-section in Rhino.

Right: Interpolation of 2010 cross-section in Rhino.

It can be seen the creek has been widened from 2010 to 2018. However, there are uncertainty and assumption using interpolation because the cross section survey were conducted at different locations in 2010 and 2018, and the 3D surface was generated based on algorithm.
