Persistence and Effectiveness of Livewood
as
Large Wood in River Restoration

Danielle Charleston, Melissa Hassler, Kelsey Wilson
University of California Berkeley
Professor Matt Kondolf
River Restoration
Fall 2018

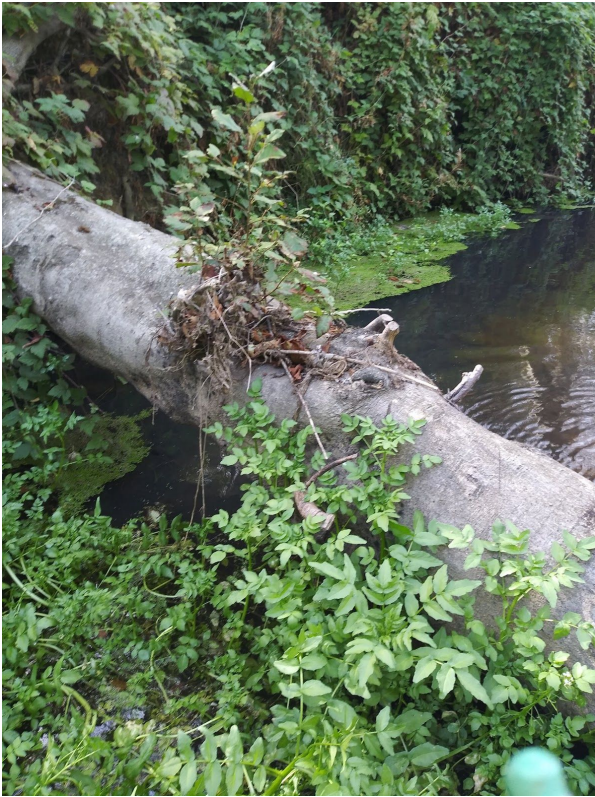
Figure 7: Site 3 Butano Creek

Area of new growth on one bole.
 Photographs by Kelsey Wilson

Close up of new growth at site 3.

Two years after installation, the Butano Creek project has two Alders (Figure 7) that are partially alive, see Table 2. On site 4, a total of three root wads with six boles were used to create the LWC. Of those six boles, two showed signs of sprouting, the remaining four appeared dead with no growth. On site 3 there are two root wads with four boles. The first root wad did not appear alive, the second root wad showed some signs of sprouting on one bole.

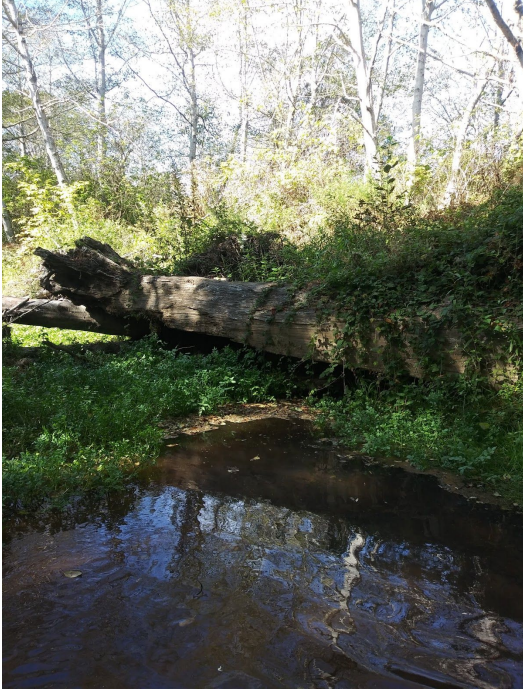
Figure 8: Butano Creek Site 3

A large redwood log on the bank of the creek that accumulated upstream of the LWC at site 3 in Butano Creek.
Photograph by Kelsey Wilson

At Butano and Scotts Creek we visually confirmed that the livewood LWCs are accumulating small woody debris during storm events. We observed livewood that is no longer living has accumulated small debris. In Butano Creek, a large redwood trunk and stump have been recruited by LWCs on site 4 and 3, respectively (Figures 8 and 9).

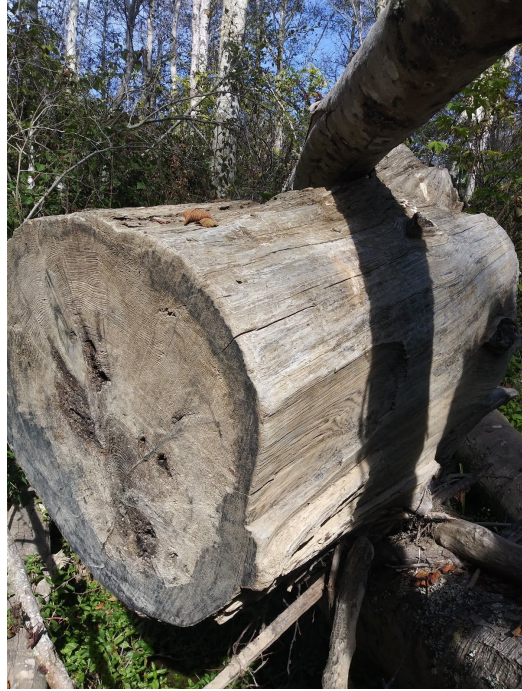
Figure 9: Butano Creek Site 4

A large stump accumulated between the two alder boles at site 3 in Butano Creek.
Photograph by Kelsey Wilson

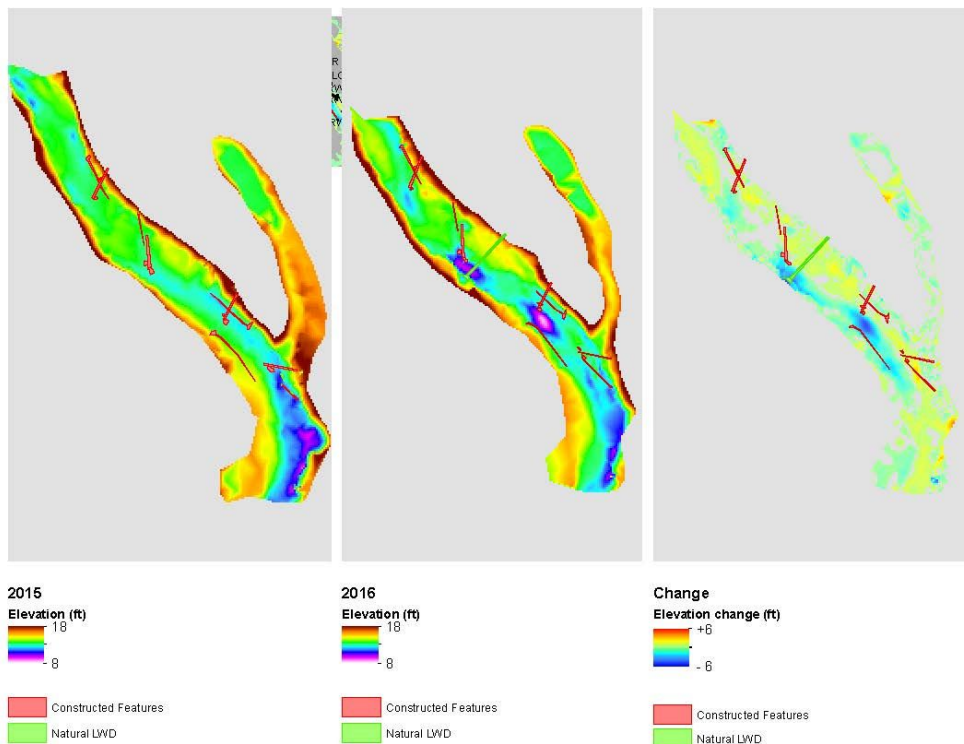
Figure 17: Scotts Creek Phase 2

Cal Poly Researchers measured geomorphic changes on phase 2 using a Total station.

Cal Poly Researchers have measured geomorphic stream changes on Scotts Creek since the completion of Phase 1 and 2. The recruitment of live wood increased the volume and roughness of the large wood complexes, and contributed to the hydraulic effectiveness of the wood structures at doing work in the stream channel and influencing hydraulic processes of pool scour, bar/riffle deposition, and sediment sorting. The geomorphic changes for Phase 1 show pool creation and an increase in streambed depth variation (Figure 16). Phase 2 geomorphic changes show more dispersed pool areas as well as some naturally recruited large wood (Figure 17). Geomorphic analysis revealed that overall habitat volume increased for Phases 1 and 2. A geomorphic analysis for Phase 3 has not yet been completed.
