Floodplain Restoration at the Old Orick Mill Site

Abstract

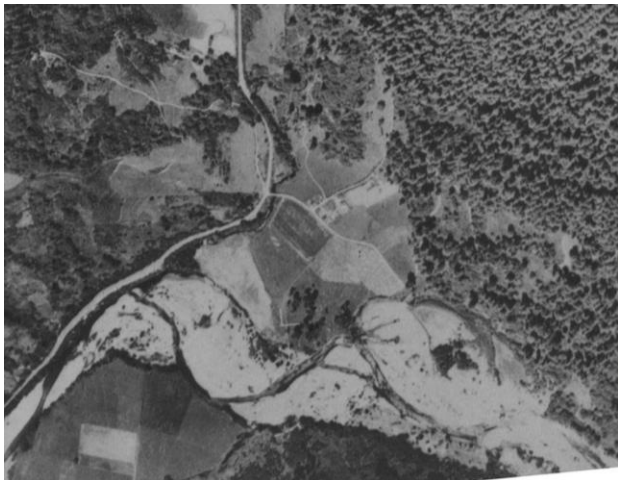
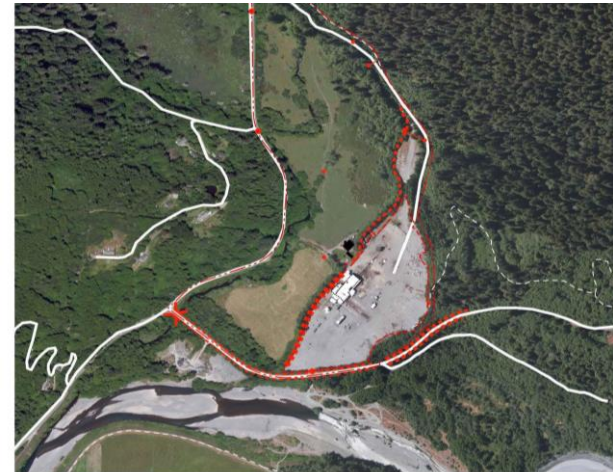
Figures 5 & 6. Aerial photos depicting changes to the floodplain. Left: 1936 Aerial Photo, Right: 2016 Aerial photo with infrastructure highlighted. The range of floodplain was markedly decreased and vegetation took over the edge of floodplain.

The oldest existing photo of the Orick Mill Site was taken in 1931, after some changes in land use had already taken place. An analysis of these photos reveals ongoing changes to the floodplain influenced by historical events since the 1930s. In 1931 and 1936, Redwood Creek was a transient, meandering channel on a wide open floodplain that shifted in response to flood disturbances. During that time the confluence of Prairie

and Redwood Creek covered a wide the floodplain (Figure 5). In later aerials, the floodplain becomes choked by infrastructure, including the construction of the old and new Bald Hills Rd bridges as well as flood control levees. The photos show an accumulation of sediment on the floodplain followed by the propagation of shrubs and large trees along flood control levees and infrastructure developments. (Figure 6)

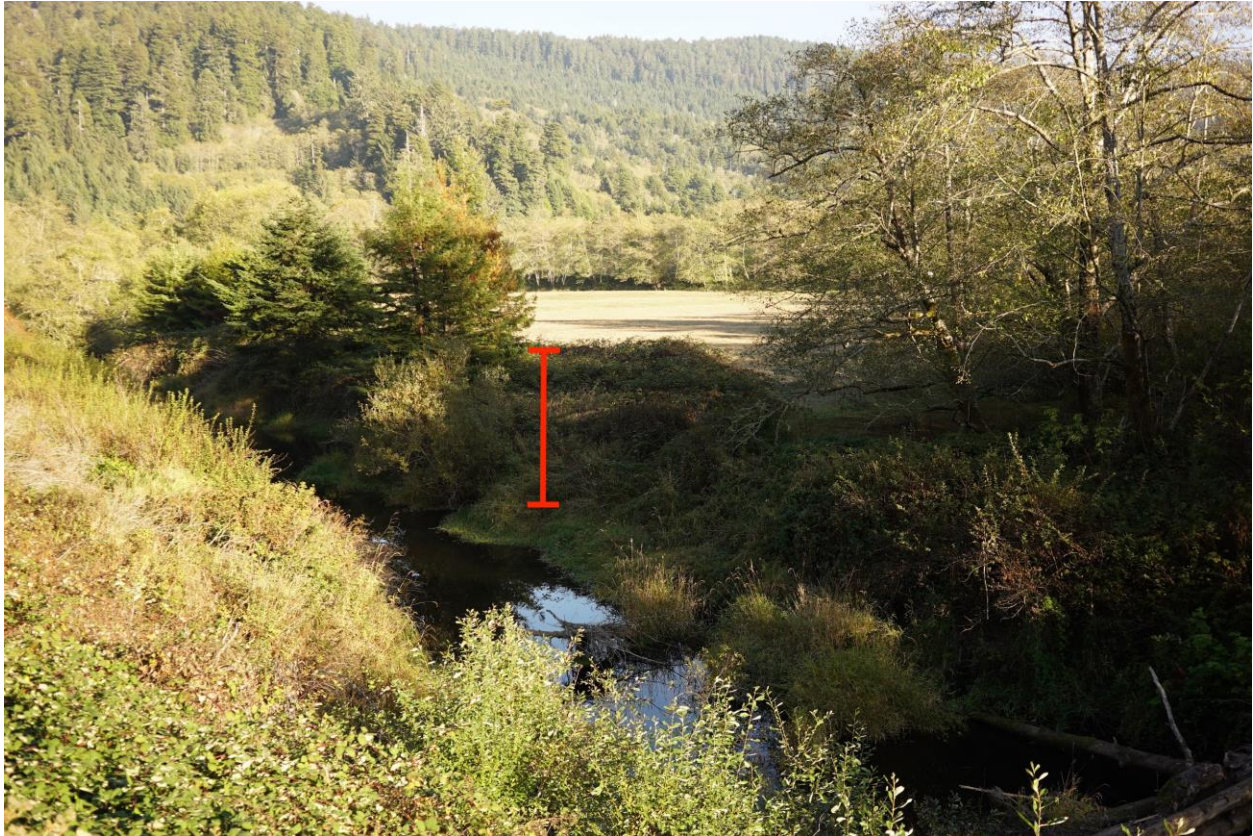
Figure 9. Height drop between floodplain and the Prairie Creek channel

The lateral connectivity of the creeks is severely restricted by several causes. The Old Bald Hills Road, built prior to 1931, acted as a levee, ponding floodwaters and inducing sediment deposition. This has resulted in an elevation difference of three feet between the north side of the mill site and the south pasture. A flood control levee and pasture constructed parallel to Prairie Creek in the 1960s further confined the creek channel and floodplain. The new Bald Hills Road overpass, constructed on fill in the 1960s, cuts through the remaining floodplain at the confluence of Prairie and Redwood Creeks. The new overpass and the adjacent gravel mine built across from the mill site on private property caused an increase in sediment deposition, floodplain elevation and incision of the Prairie Creek Channel (Figures 9 & 10). The construction of Highway 101 in the 1980s further confined the Prairie Creek channel along the east side of its floodplain. Vegetation has gradually taken over the banks along the creeks indicating compromised hydrologic and geomorphic processes of Prairie Creek and reduced lateral connectivity of the floodplain. (Figures 11)

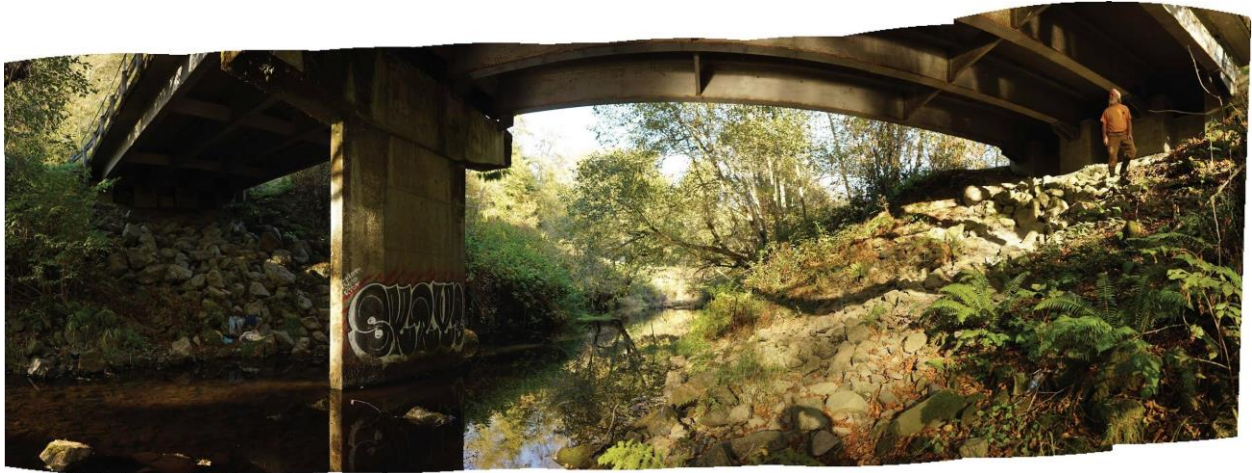
Figure 11. The narrowed Prairie Creek channel and confining structures of New Bald Hill Road overpass from both sides

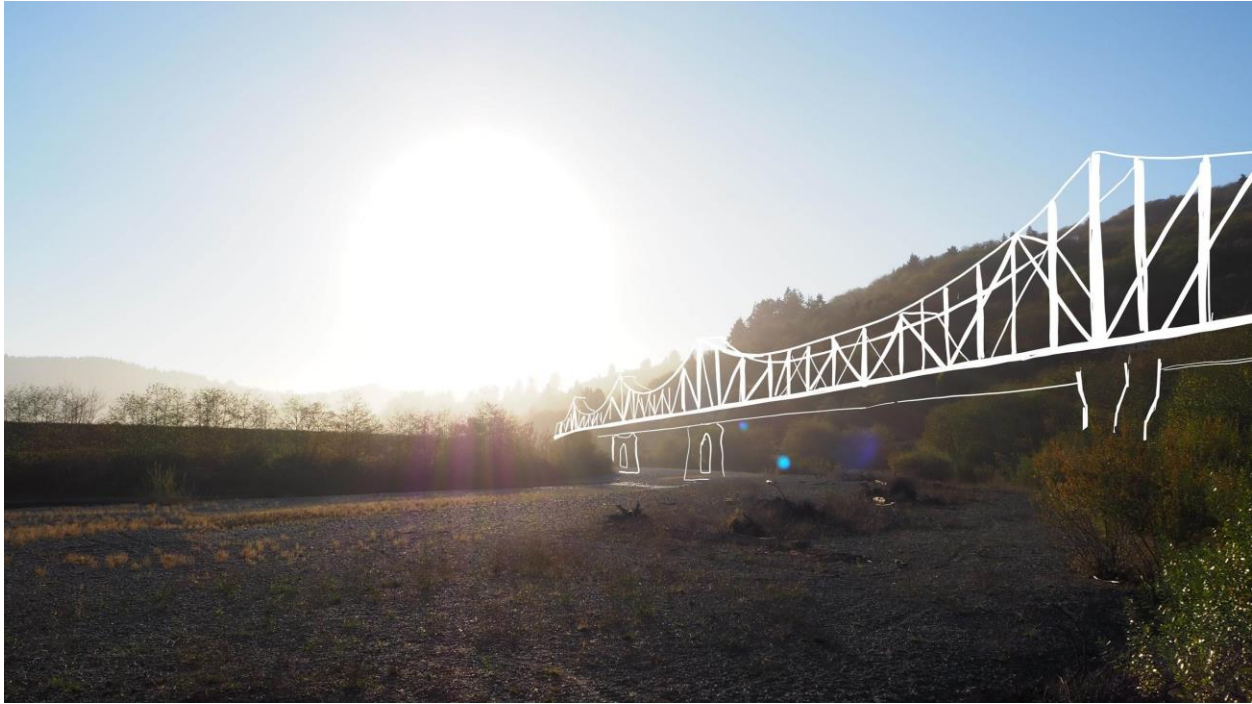
Figure 12. One of the envisioned alternatives to New Bald Hills Road overpass

We suggest widening and relocating the overpass to allow for a larger floodplain . A redesign of the Bald Hills Road overpass to pass flow would allow natural hydrologic and geomorphic cut and fill processes and channel migration thereby improving the floodplain habitats. In order to accommodate variable flood events, the Bald Hill Road levee should be replaced with an elevated roadway passes flow and allows sediment to pass naturally through this system. An elevated roadway such as a mini-causeway or a series of long arch culverts with minimal interference would be ideal solutions (Figure 12). A causeway would enable lateral movement of floodwaters, but the many structural foundations in a typical causeway would still limit sediment transport, requiring maintenance and removal of sediment. Therefore we recommend a longer span bridge with foundations every 30-40 feet. A longer span bridge would allow dynamic movement of the creek and natural cut and fill processes across the gravel bed floodplain.
