Finding a Foothold on an Uncertain Bank: An Assessment of Cerrito Creek into the Blake Garden

Nery Barrera Lopez, Moyan Chen, Timothy Cole, Tanner Howe, and Sara Mahmoud

LA 227 Restoration of Rivers and Streams
University of California, Berkeley
December 16th, 2019

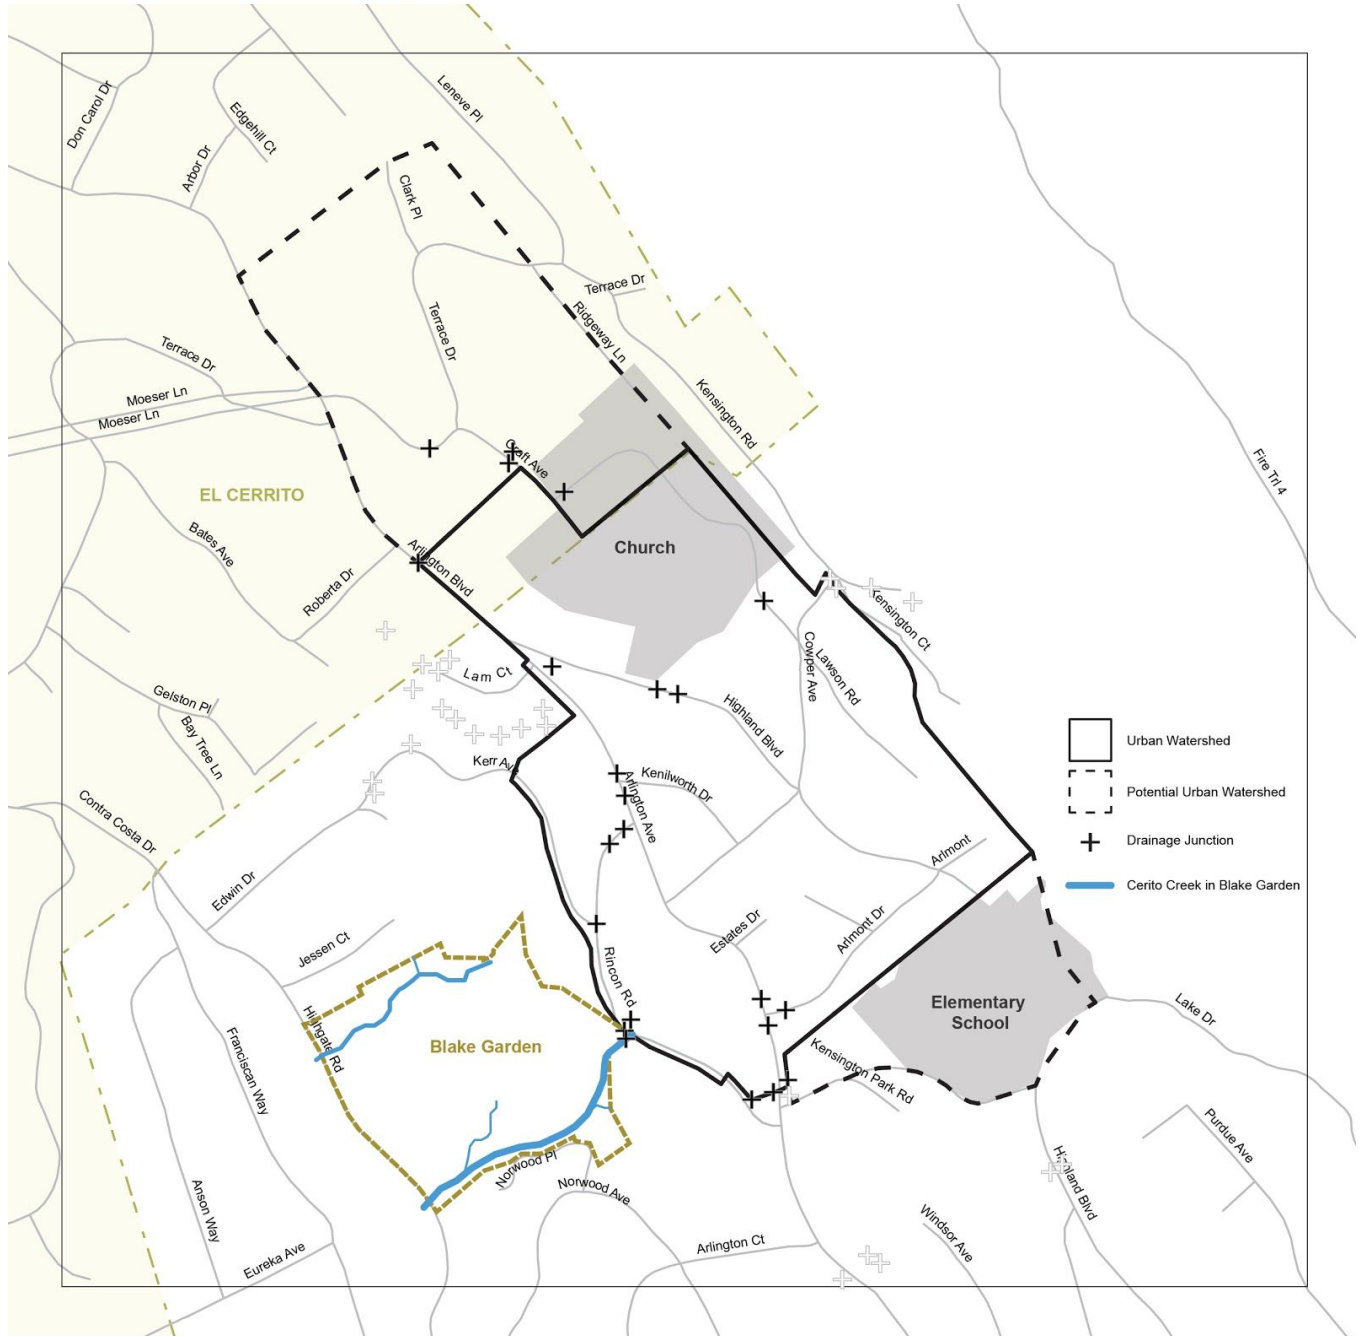
After two inspections of the watershed above the Blake Garden, we could not determine the exact catchment area. However we were able to delineate what we believe to be the most accurate estimations to date (Figure 14). Figure 14 shows the catchment area for the water that drains into the southeastern reach Blake Garden, and it is divided into three subsections. The section in the middle of the catchment, denominated “Urban Watershed”, is the area that certainly drains into the creek. This area includes the topographic catchment area and the area that drains into the creek by piping. The two areas (north and south of the Urban Watershed), denominated “Potential Urban Watershed” are areas that potentially and likely drain into the Blake Garden depending on certain conditions. These areas were included because the storm drains maps provided were inconclusive, the north being within the city limits of El Cerrito, and the south mostly consisting of Kensington Elementary School. The catchment area then could vary from 46.75 acres, the area which certainly drains into the garden, to 77.39 acres, which

Figure 14. Delineation of Watershed/Catchment Area

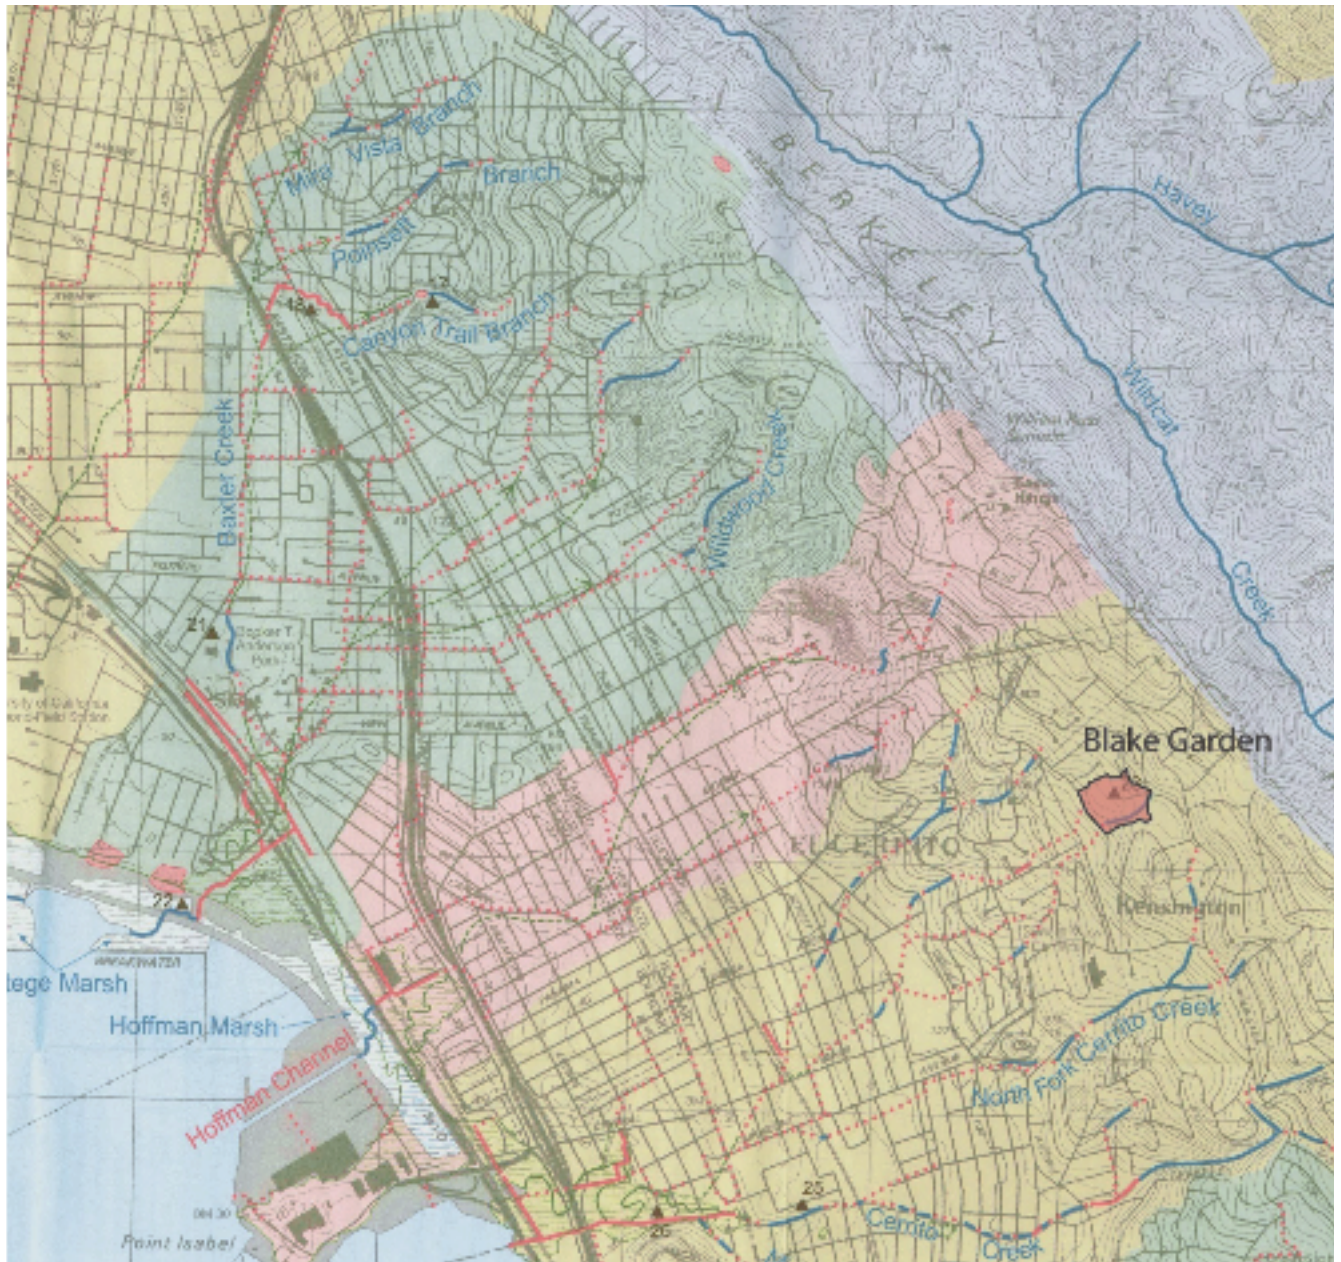
Our initial thought was to analyze topographic maps of the region around the upper reach of Cerrito Creek in parallel with the drainage area maps (Figures 16 & 17). We observed a relatively flat region depicted on the topographic map east of the reach of Cerrito Creek within Blake Garden. We suspected this region to be the extent of the floodplain. Upon field observation, our suspicions were confirmed. With the permission of Marion Bardin, owner of the property east of the Blake Garden, we examined the flat portion of land as shown on the topographic map. The plain included abundant riparian vegetation, standing water, and was level with the plain extending into Blake Garden, as shown in figure 14. It was also evident that there are active flows through the Bardin property, mostly in the subsurface. The water that originates in the Bardin property flows into the eastern branch of the upper reach of Cerrito Creek, which in reality originates from the Bardin property, not the Blake Garden.

Figure 17. Cerrito Creek watershed (Oakland Museum).
