# **Baxter Creek Gateway Park Restoration**

## **A Post-project appraisal**

University of California, Berkeley

LD ARCH 227 - Restoration of Rivers and Streams

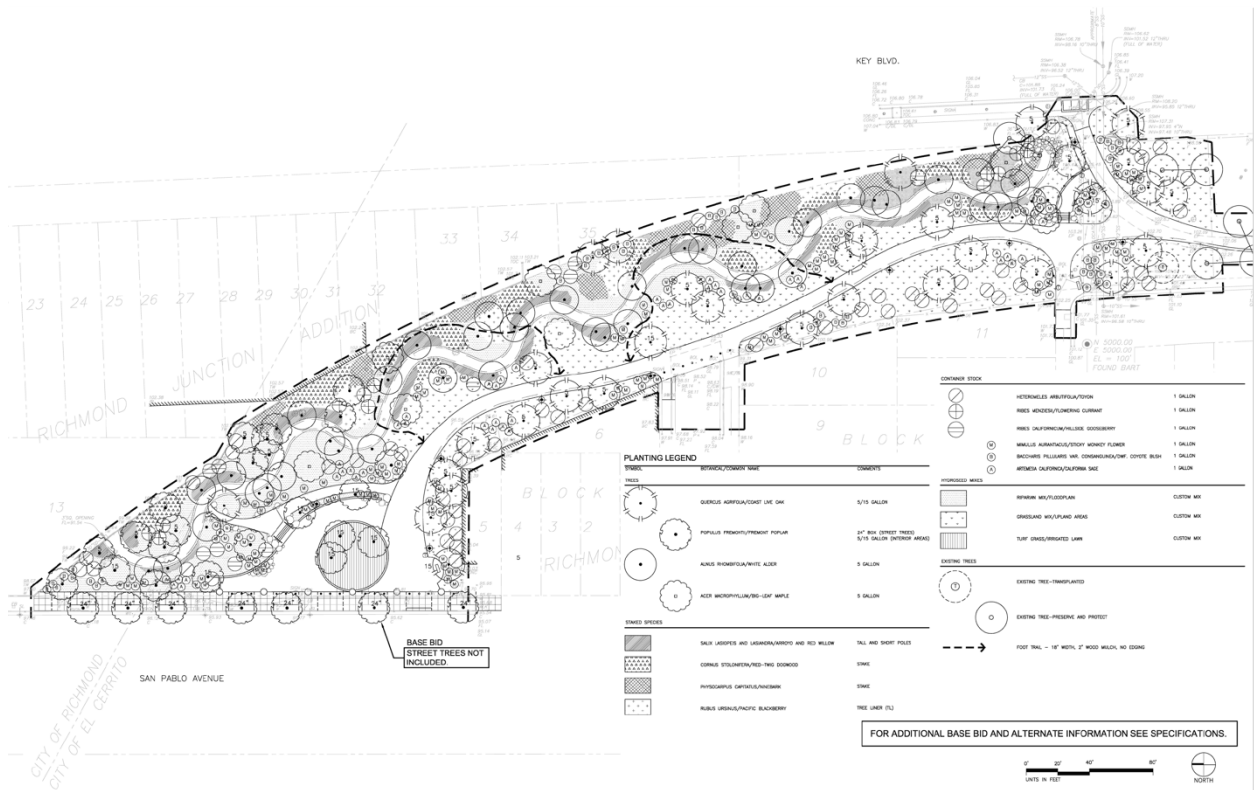
Figure 2.4.1: Baxter Creek Site Reference Map

During the dry season, the midstream and downstream of the channel was dried out (figure 3.1.3), only the part of upstream have still water but most of which are covered by aquatic vegetation. Some parts of the creek bed are higher and intended to create the lateral connection (Figure 2.4.1). But as a result, these engineered weirs stop water flowing and create a small pond in the dry season (Figure 3.1.4).

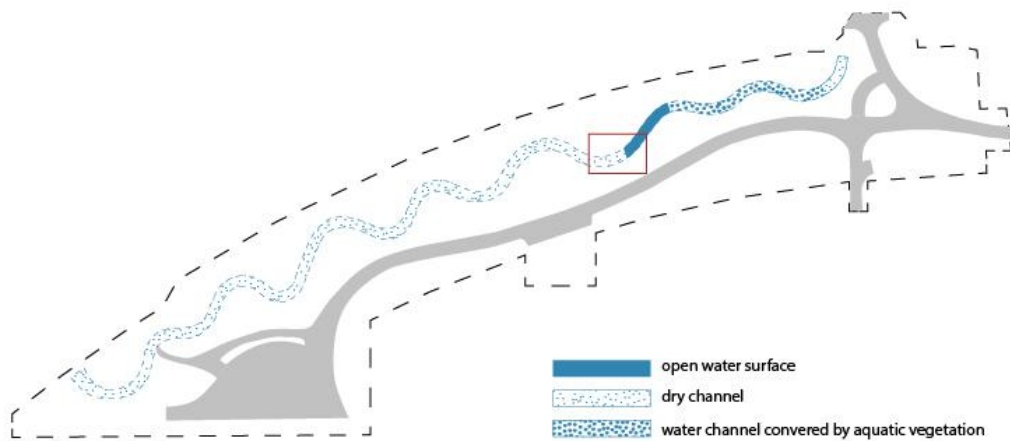
Figure 3.1.1 Creek bed condition in dry season (base on the field visit on Nov.24<sup>th</sup>)

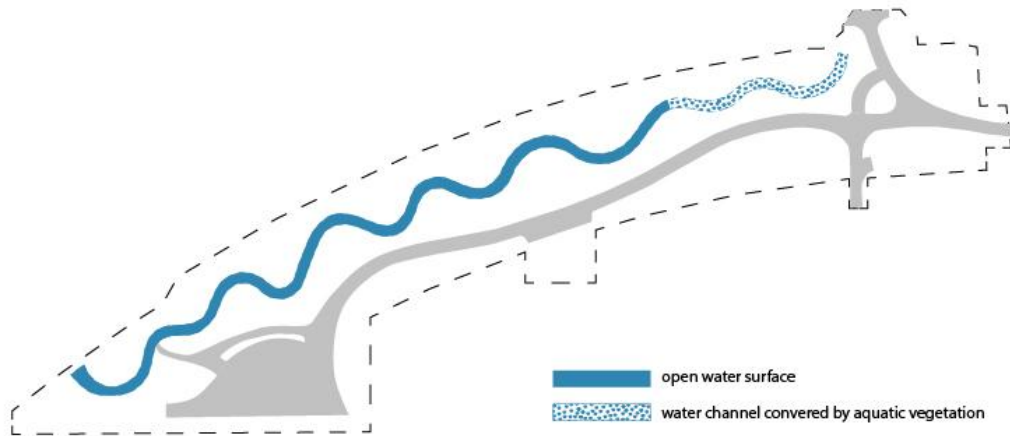
Figure 3.1.2 Creek bed condition in wet season (base on the field visit on Dec.3<sup>rd</sup>)

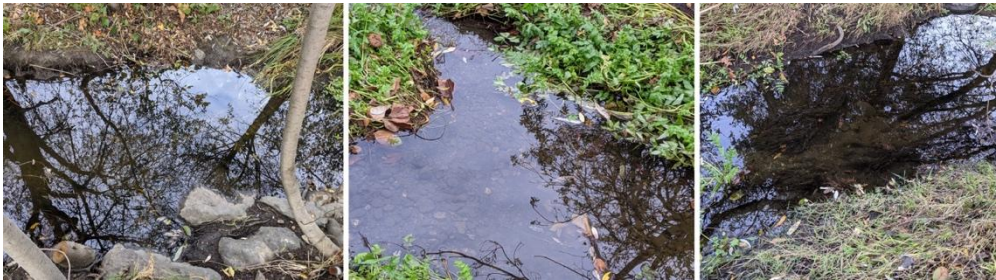
Figure 3.1.5 different creek bed material (base on the field visit on Dec.3<sup>rd</sup> )

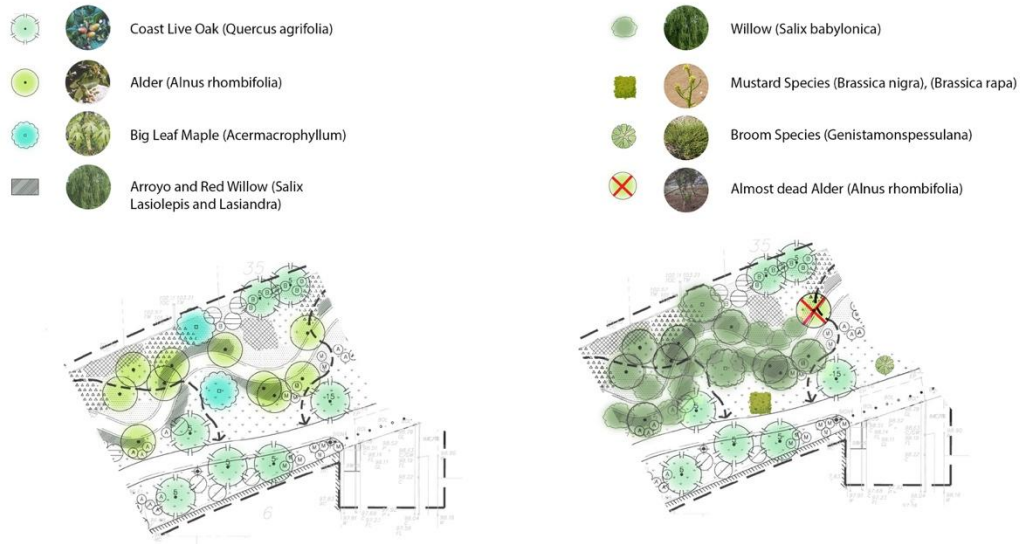
The trees shown in the planting plan (Figure 3.3.1) have some are in good condition, and some are not. The Oak grows in good shape, but the Alder and big leaf maple are hard to recognize, most of them are dead and not functional anymore ( Figure 3.3.2). Moreover, the "container stock" bushes were hard to discover in the selected area, where there was just bare soil and some covered with grass. According to species studies, we found several invasive species in our chosen field, such as Mustard Species, which grows along the road, and Broom Species, which grow flourishingly in our site. Another significant issue is the expansion of willows, which take over space and shading large amounts of area, thus competing for the sun and nutrition with other riparian plants and blocked the creek view.

Figure 3.3.1: Plant species evolvement

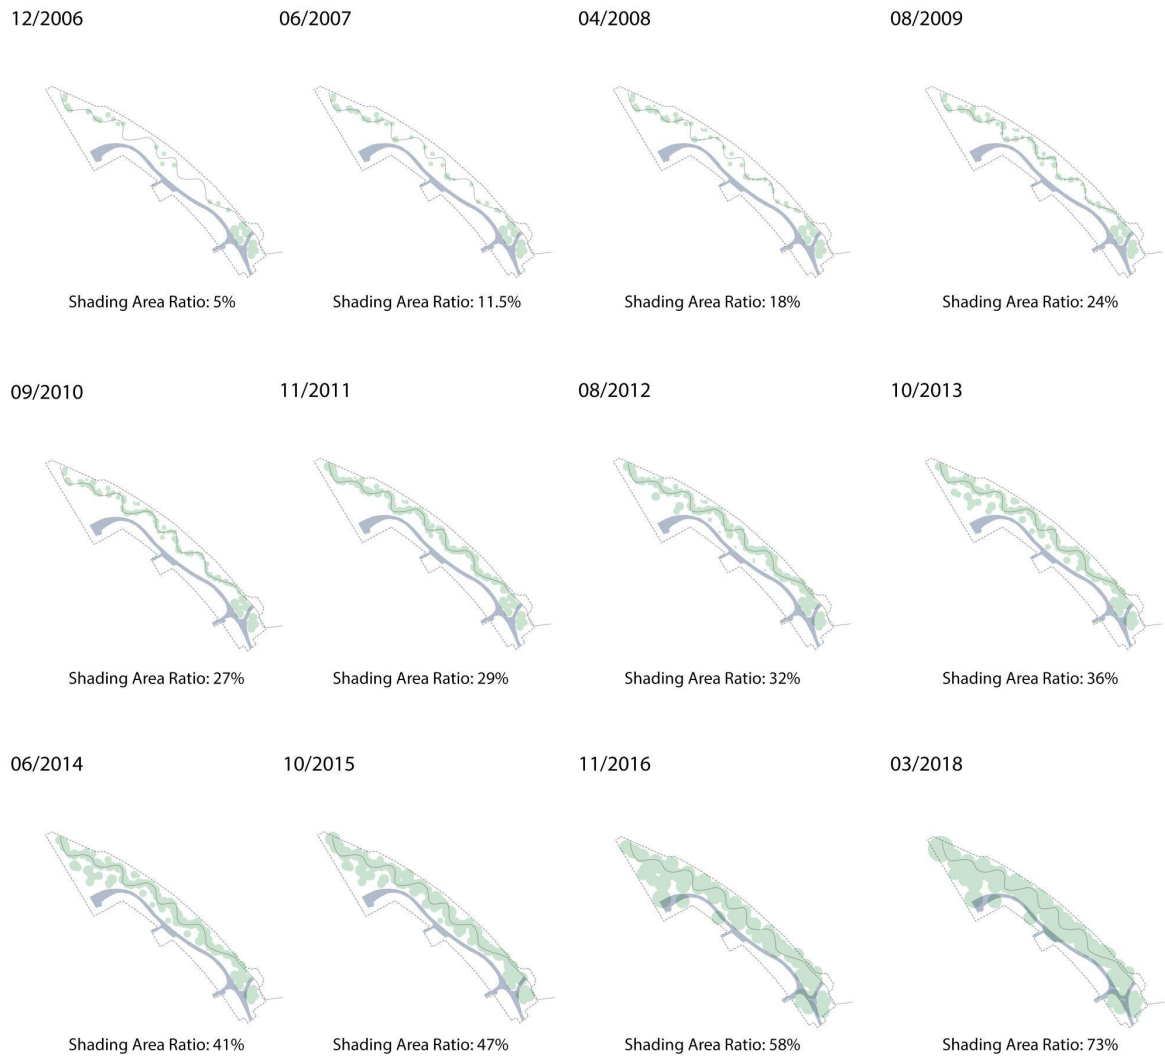
almost every corner of the site. It is quite evident that the plants have been increasing steadily as time goes by and the growing speed is terrific. (Figure 3.4.1)

Figure 3.4.1: Plant shading space evolution
