What's Past is Present: A Re-Evaluation of Cerrito Creek

University of California, Berkeley

LD ARCH 227 - Restoration of Rivers and Streams

December 17, 2018

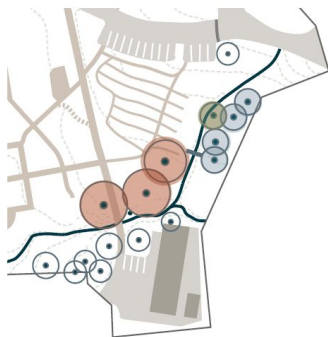
Figure 3: Existing plant plan

The 2010 study included an existing plan within the reach (Figure 3). Based on the study, we identified the existing shrubs and groundcover planting species, as well as the invasive and poisonous species with the help of Timothy Cole. According to the prior studies and Timothy's opinions, we concluded the main problem of the planting would be tall shrubs blocking views and erosion on the barren bank.
